Wear Analysis of Linear Bearings

By William R. Herguth
(Member, STLE)
Herguth Laboratories,
Inc.
Vallejo, California

Douglas Godfrey
(Fellow, STLE)
Wear Analysis
San Rafael,
California

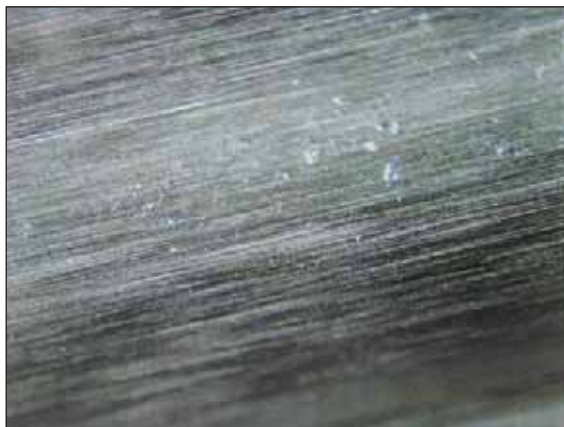
Figure 1. MICROGRAPH OF DENTS IN BALL RACEWAY OF STAND

(30X Shows Original Grinding and Dents in Center of Raceway)

shop air, which may be dusty. As shown in the micrograph in *Figure 1*, the raceway on the far upper end of the guide was dented. This was not visible to the unaided eye. Further down the raceway, significant damage in the form of disturbed metal was observed. At the beginning of the severely damaged area, isolated shallow pits with cracked metal adjacent to the pit were observed (*Figure 2*). Pits and associated cracks are evidence of rolling contact fatigue. In the severely damaged area, cracks, pits and deformed metal were observed, as shown in *Figure 3*.

Dents in the guide raceways indicate solid particles were rolled between the balls and the raceways. Dents are known to create stress-raising sites and cause early surface-initiated contact fatigue failure. Cracks can be subsurface or surface initiated. The dents indicate that the grease contains solid particulates, probably contamination from the environment. The author assumes the stand is exposed to laboratory air that may be dusty. Dirt in lubricants could be an exacerbating factor. Therefore, protection of the unit from dust should be considered.

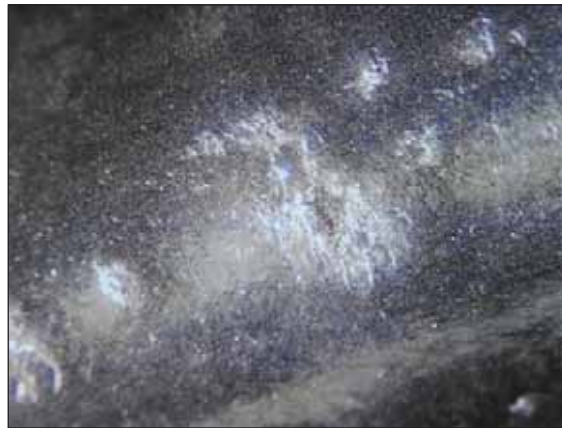
Figure 2. MICROGRAPH OF ISOLATED PITS IN BALL RACEWAY OF STAND

(30X Shows Pits and Associated Cracks)

face-origin spall caused by surface stress concentration." Pitting accounts for the generation of large amounts of metallic wear debris. The particles are loosened by the extended cracks. Then most of the free chunks are rolled upon to form flakes.

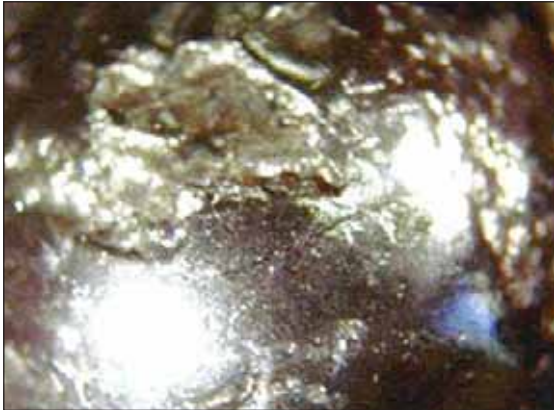
Figure 3. MICROGRAPH OF SEVERELY DAMAGED BALL AND RACEWAY

The balls in the upper row of the linear bearing were in good condition. But the balls in the lower row were severely damaged, the same as the stand raceway. The micrograph of the ball in *Figure 3* shows a large crack, pits and deformed metal characteristic of several balls examined.

Ball With Large Crack

The most common cause of premature contact fatigue is overload because it increases stress and thins oil films. The localized damage of the contact fatigue on the linear bearing suggests overload on one row of bearings. This could be due to misalignment due to twisting or some other mechanical condition, such as uneven distribution of load. Therefore, a re-examination of load distribution is suggested.

To reduce contact fatigue failures one should consider several measures: the use of steel 52100 with better fatigue resistance, the possibility of non-uniform loading, and the reduction of solid and water contaminants in the grease. <<

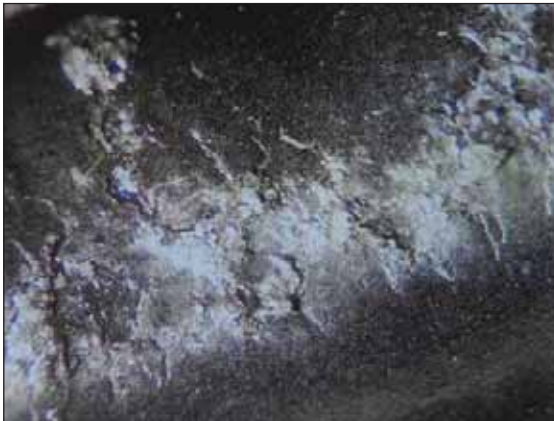
Raceway with Cracks and Pits
